The cable design which has been associated with "rocket engine" defects, within the optical fiber, and later with low breaking strengths of the fiber, has been that defined by the ISS specification SSQ21654 (plus engineering modifications) and given the Boeing Company part number NFOC-2FFF-1GRP-1. Some small amounts of a similar part number, NFOC-2TFF-1GRP-1 was also used in ISS hardware; however, the problem investigation reported here does not concern this second part number. The production period of concern spans between June of 1996 to July of 1999. End users were Boeing-HB, ISS partners, and their subcontractors.

9.0 RECOMMENDATIONS

The initial goal of this investigation was to understand the cause of the "rocket engine" defects found in the fiber contained in the NFOC-2FFF-1GRP-1 optical cable being used by Boeing in International Space Station hardware. It was believed that if the root cause of the rocket engine defect could be found, the handling or the manufacturing processes (or both) could be engineered to eliminate the defect from future hardware. As the investigation progressed, these defects began to be understood as distinct and related to synergistic processes occ

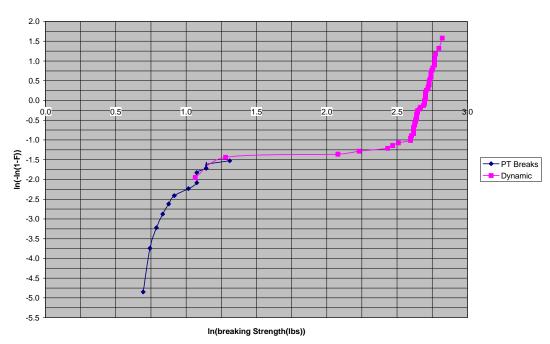
Figure 38 Mandrel Used for Screening Evaluation

Testing was performed to determine if a mandrel proof test could be performed as an incoming screen to remove low strength fiber. Figure 36a and 36b shows the mandrel arrangements and sizes used. Lengths from cable lot 04245 and 04255 had been strength tested as discussed in section 7.1 above. The 04245 lot was found to contain more low strength sites than 04250 though the 04250 lot also had similarly weak links. Both of the samples were screened for glows with a HeNe laser and for echoes with an OTDR. This established that the 04245 sample was starting the evaluation with at least one flaw. No glows were found for the 04250 sample and no echoes were found for either. The samples were then submitted to the proof test, which extended roughly 100 kpsi (2.4 lbs) to the cable.
